Manhole Inspection Summary

Manhole # S37Q__045MH

Insp Date: **1/16/08 1:38 PM**

Location Address: **covington st**

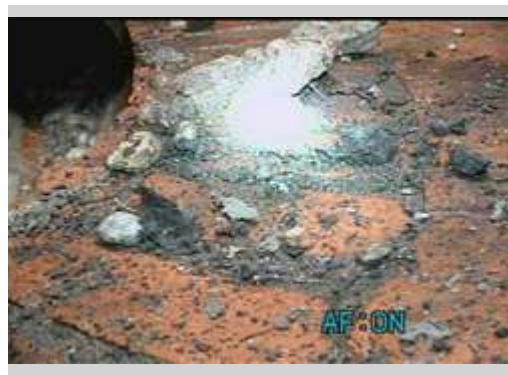
Misc

bench debris

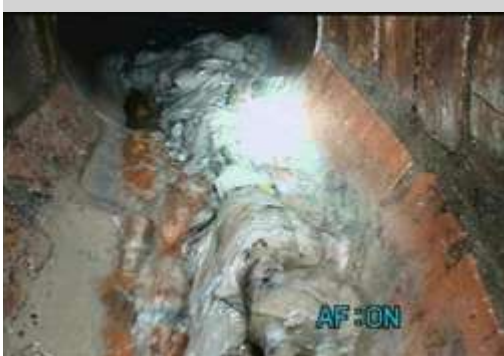
Misc

channel debris

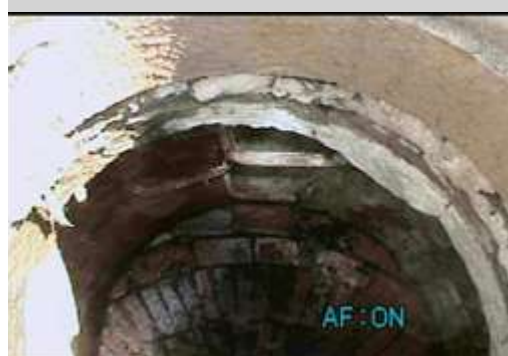
Defect 3

Steps Count: **3** Missing: **0** ☒ **Corroded**

corroded steps

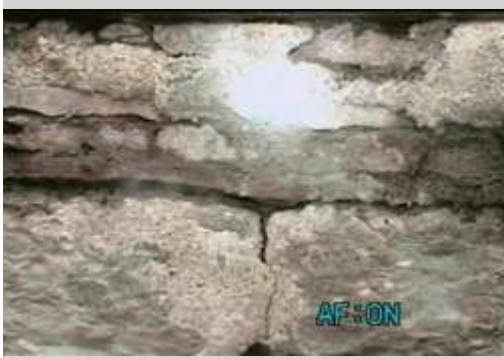
Defect 2

Condition: ☐ Sound ☒ **Cracked** ☐ Root Intrusion ☒ **Loose Brick** ☒ **Deteriorated**

loose bricks, cracked chimney frame adj

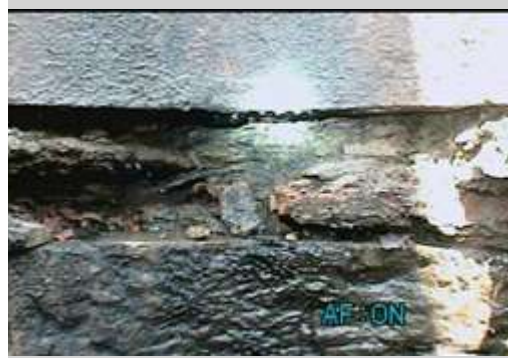
Defect 1

Infiltration: ☐ None ☐ Joint ☒ **Cracks** ☐ Mortar ☐ Roots ☐ Wall

chimney infiltration in frame adj

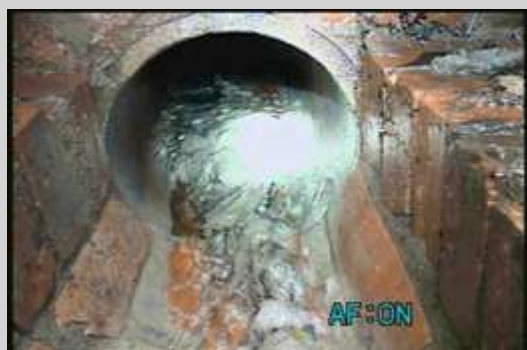
3 O'Clock Inflow

Deposits: ☐ None ☐ Mud ☐ Sludge ☒ **Debris** ☐ Grease

Silt Depth: 2 (in.) Deposits Extent: **Medium**
